Experimental Study on Inter-Laminar Short Circuit Faults at Random Positions in Laminated Magnetic Cores

Hamed Hamzehbahmani^{1*}, Philip Anderson¹, Keith Jenkins² and Magnus Lindenmo³

Abstract— Inter-laminar short circuit faults between the laminations of electrical machines, and other magnetic devices, have been one of the major challenges for the suppliers and customers of electrical steels. Extra power losses caused by inter-laminar faults depend on many factors including the location of the fault points. In this work fundamental definitions and concepts of inter-laminar short circuit faults, effect of inter-laminar faults on configuration of the magnetic cores and FEM verification are presented. Experimental works were performed to study the effect of inter-laminar faults with different configurations on the total power loss to distinguish and locate the critical and destructive faults. In the relevant studies, artificial short circuits of different configurations were applied between laminations of packs of four Epstein size laminations of 3 % grain oriented silicon steel. Extra power losses caused by the inter-laminar faults were measured and the results were analysed.

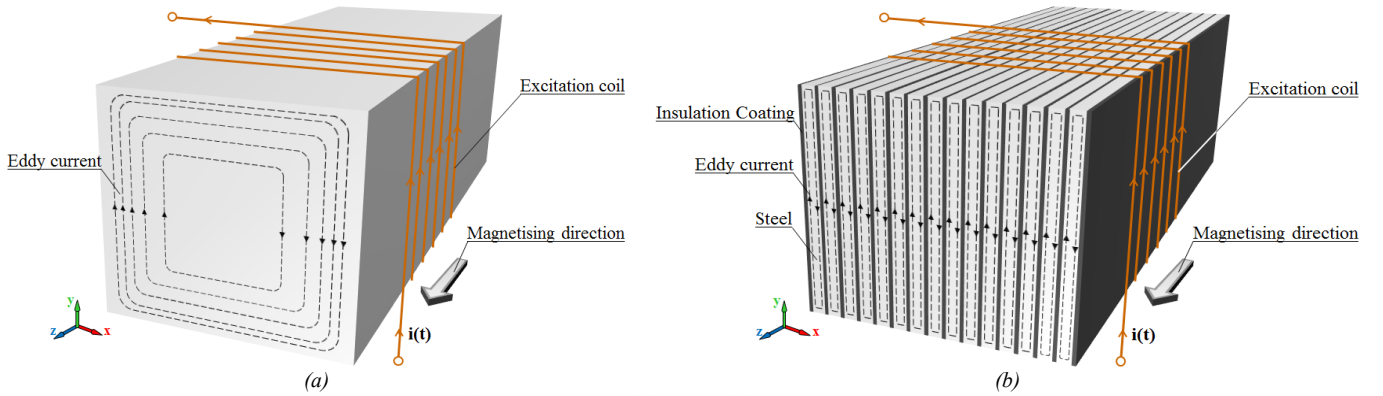
Fig 1 Eddy current in (a) solid core and (b) laminated magnetic core

MAGNETIC cores of commercial electrical machines, and other magnetic devices, are constructed from stacks of electrical steel laminations, typically 0.23 to 0.50 mm thick. Laminations are coated with insulating layers to prevent electrical contact between them [1]. This limits the circulation of eddy currents to the thickness of single lamination, rather than the whole core, and hence reducing the eddy current power loss and overall heating effect in the cores [2]. Electric paths for the induced eddy currents in magnetic cores with solid and laminated structures under time-varying magnetic field are shown in Figs 1-a and 1-b, respectively. In a perfectly assembled core, when the laminations are well insulated from each other, the eddy current loops are restricted to the individual laminations, as shown in Fig 1-b.

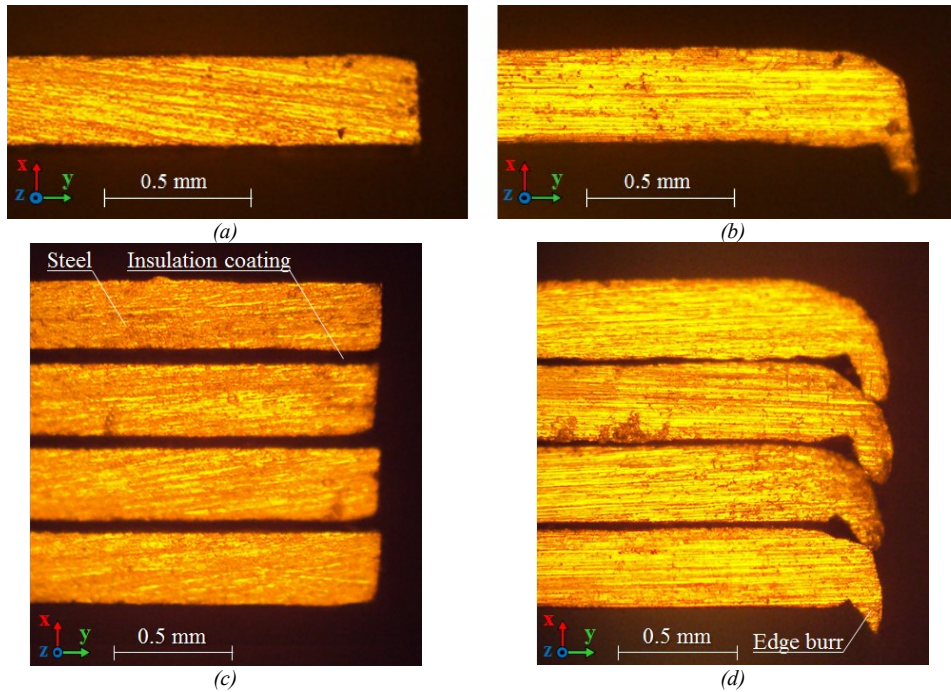
Fig 2 Side view of a single lamination cut by a (a) sharp (b) blunt guillotine; stack of laminations with (c) properly cut samples (d) samples with edge burr

In order to show concept of the edge burr physically, magnetic laminations of 0.3 mm thick CGO *Fe 3 % Si* were cut by one sharp and one blunt guillotine. Stacks of four laminations were then made with clean cut samples and the laminations with edge burr. Side view of the samples and each stack was imaged using an ERCOLUX standard optical microscope with a resolution of 1 μ m; the results are shown in Figs 2-a to 2-d, respectively. Fig 2-c shows an ideal configuration of a magnetic core in which the laminations are properly insulated from each other; however Fig 2-d shows the inter-laminar short circuit caused by the edge burr.

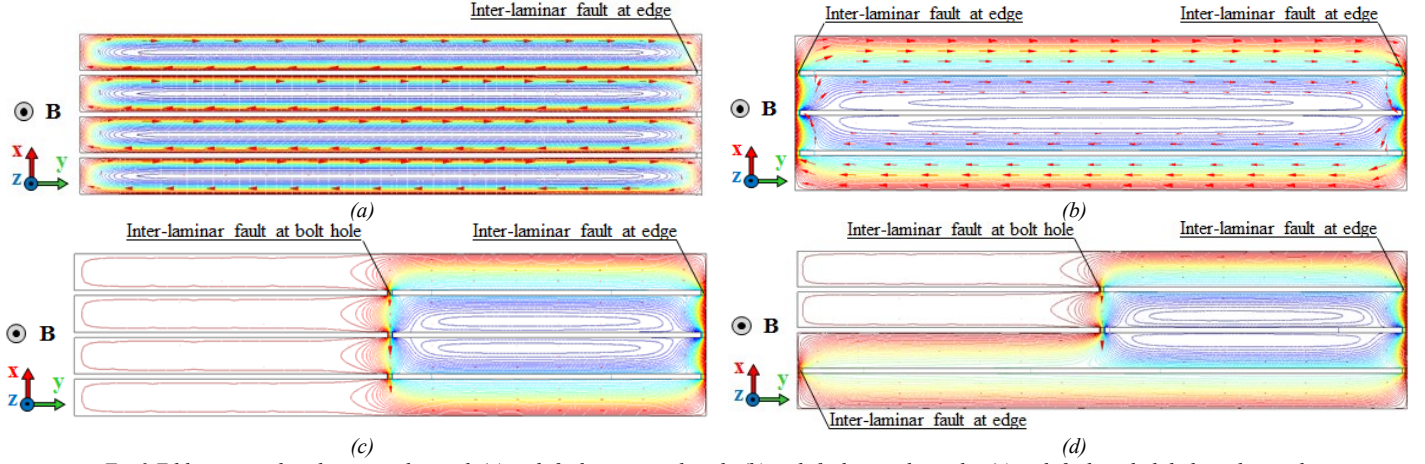
Fig 3 Eddy current distribution in the stack (a) with fault on one side only (b) with fault on either sides (c) with fault on bolt hole and one edge (d) combination of faults "b" and "c"

A quantitative verification was performed by the authors [3] using COMSOL Multiphysics to survey the effect of inter-laminar short circuit caused by edge burrs on the configuration of the magnetic cores. The simulation model was then extended by considering the inter-laminar faults around the bolt holes. In this study a stack of four laminations exposed to a time-varying outward magnetic field with a frequency of 50 Hz was considered. Laminations were modelled by 3 % GO silicon steel. Partial blocks, of the same material as the lamination, were implanted to model inter-laminar fault caused by the edge burrs. Considering the theoretical base of flux density penetration into the magnetic laminations [15], each stack of laminations was magnetised at a typical peak surface flux density of $B_{pk}=1.5$ T. The model requires an extra fine mesh and hence a long calculating time, approximately 30 min for each model. Eddy current distribution in the stack with inter-laminar fault on one side only, on either sides, between the bolt hole and one side and a combination of the last two cases are shown in Figs 3-a to 3-d, respectively.

Four important points could be concluded from the FEM results of Fig 3:

1. Inter-laminar fault on one side of the magnetic cores, does not create fault current loop and hence does not affect the normal distribution of eddy current in the individual laminations and eddy current power loss.

2. The fault current loops change the configuration of the magnetic cores to be similar to a solid core which leads to inter-laminar fault currents and larger eddy current loops in the shorted laminations.

3. Inter-laminar faults between the bolt holes and one side of the stack create a smaller fault current loop, Fig 3-c. In this case, fault currents flow between the fault points and those parts of the steels which are shorted by the fault points. Eddy currents in the other parts of the steels are almost zero; because inter-laminar faults around the bolt hole make a short path with lower resistance to flow the inter-laminar fault current.

4. Eddy current density at the shorted points is much higher than the laminations placed between them which result in high local power loss and high local heat. This is the main reason for damaging of the magnetic cores affected by inter-laminar faults.

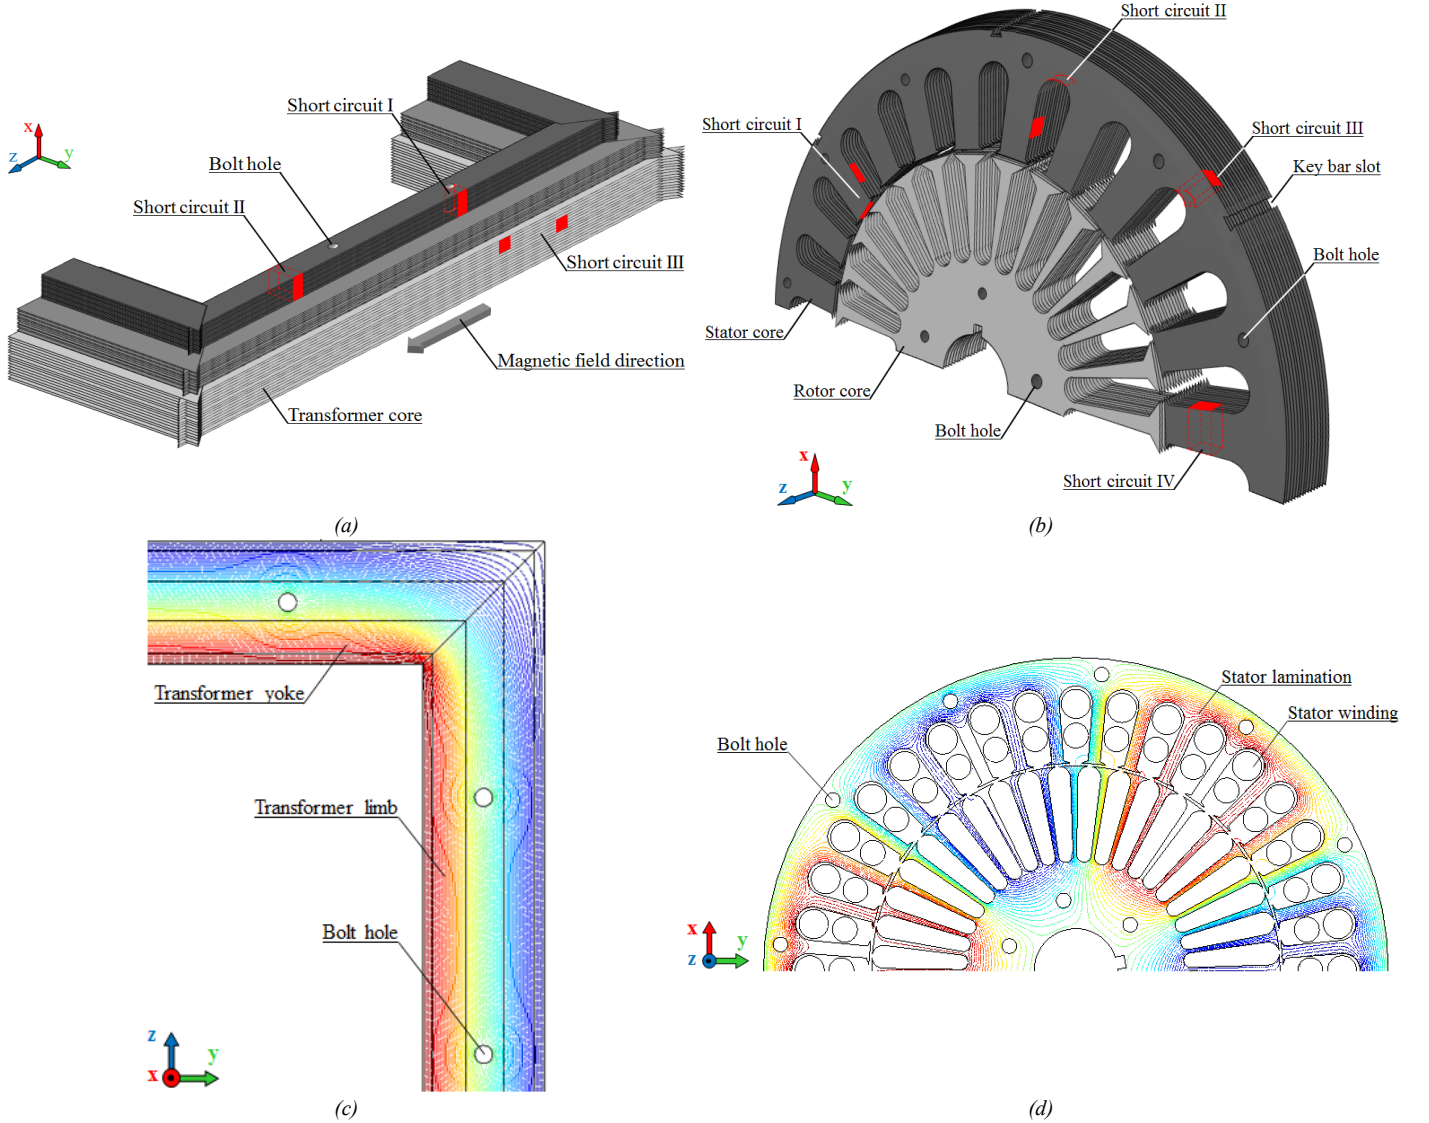
Fig 4 Perspective view of (a) a transformer limb with inter-laminar short at three possible positions and (b) a stator-rotor core with inter-laminar short at four possible positions; magnetic flux path in (c) transformer core (d) three phase 6 poles stator-rotor core

Partial inter-laminar fault in the stator cores of the rotating machines could be more destructive than transformer cores, because laminations of stator cores are welded or held together through either key-bars or the housing at the base of stator yoke [5-6], [13]. The key-bars can be, but are not always, insulated from the laminations or the frame of the stator to prevent the flow of current between cores and frame; but if not, it makes a permanent short circuit at the outer side of the core. Therefore if the stator laminations are shorted together, even on one side only, inter-laminar fault currents could be induced in the fault current loop that consists of the fault point, the shorted laminations and the key-bars, welds or housing. In order to distinguish destructive faults, a perspective view of a transformer limb with three possible inter-laminar faults and a stator-rotor core with four possible inter-laminar faults are shown in Figs 4-a and 4-b, respectively. 2-D FEM modelling was performed to visualise the distribution of the magnetic flux in both transformer and stator-rotor cores and distinguish the fault current loops; the results are shown in Figs 4-c and 4-d, respectively.

In Fig 4-a, short circuit I is formed between the bolt hole and one side of the core step and short circuit II is formed between two sides of the core step. Both of these defects are perpendicular to the direction of the magnetic flux in the core and therefore create

fault current loops. Short circuit III, on the other hand, does not meet the definition of fault current loop, because it does not make a closed loop perpendicular to direction of the magnetic flux in the core. Considering the flux density distribution in the stator core, neither short circuits I nor II of Fig 4-d cut the magnetic flux lines and hence do not meet the definition of the fault current loops. On the other hand, short circuits III and IV make closed current loops perpendicular to the direction of the magnetic flux in the yoke and tooth respectively and therefore create fault current loops in the core. However if the outer side of the stator core is shorted by the key-bar or stator frame, short circuits I and II create fault current loops in the core.

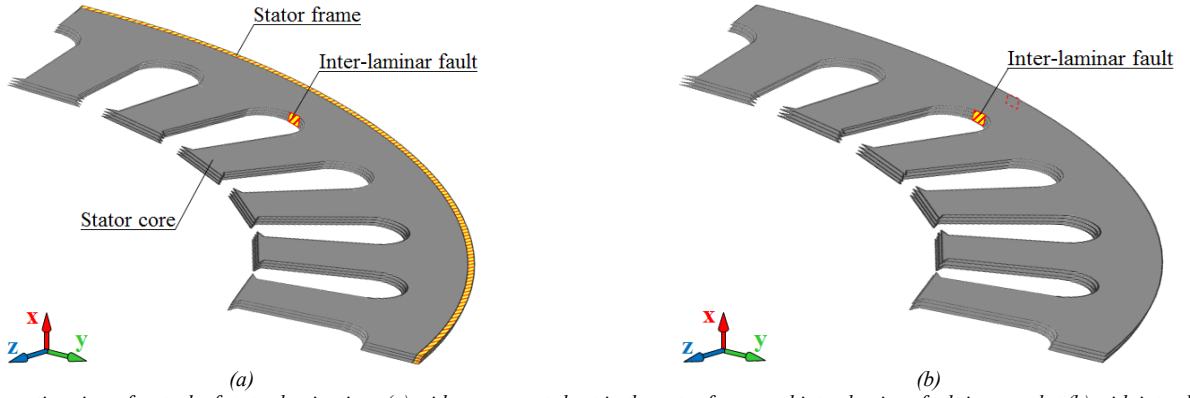
Fig 5 Perspective view of a stack of stator laminations (a) with permanent short in the outer frame and inter-laminar fault in core slot (b) with inter-laminar fault between the outer frame and core slot

Two types of short circuit on a part of stator core are shown schematically in Figs 5-a and 5-b. In Fig 5-a the outer side of the core is shorted totally and a partial fault is applied between the lamination of one of the slots; while in Fig 5-b two partial faults are applied on opposite sides of the slot at set points. As the first part of the experimental study, these types of faults were modelled separately on stacks of four laminations. A top view of the stacks showing the location of the applied short circuits are shown schematically in Figs 6-a and 6-b, respectively. The measured power losses of each stack together with the nominal loss of the material versus peak flux density at different frequencies are shown in Fig 6-c.

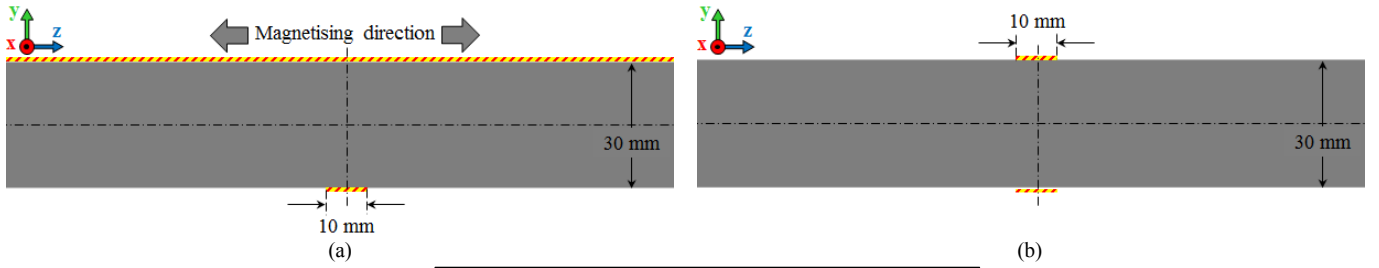
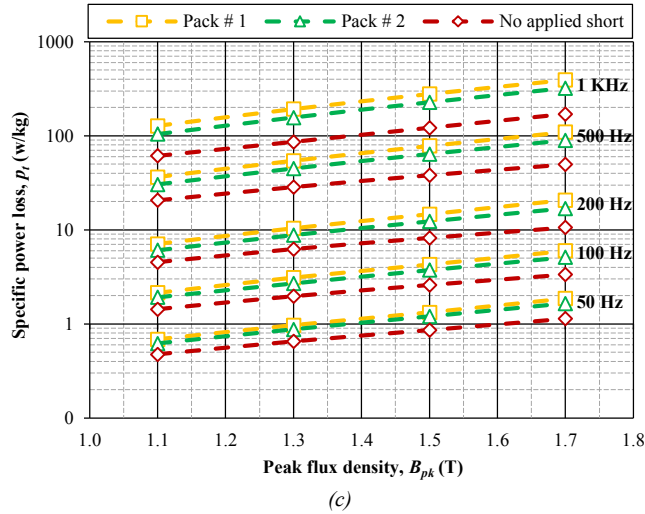
Fig 6 Top view of a stack of laminations with inter-laminar short circuit to model the inter-laminar faults of Fig 5-a (pack # 1) and 5-b (pack # 2) Comparison of total loss of the packs #1 and #2 with the normal loss of the material vs. peak flux density at different frequencies

Fig 6-c shows extra power loss in the shorted stacks compared to the normal power loss which is caused by the fault current loops created in the stacks. However, the power loss of pack 1 is higher than that of pack 2 at all flux densities and frequencies with the maximum difference of about 18 %. Although the bottom sides of both packs are shorted with artificial shorts of the same width, the higher power loss of pack 1 indicates a bigger fault current loop than pack 2, which is caused by the applied short circuit alongside on pack 1. As a result, permanent short circuits caused by the key-bar or welded frame should be considered in the study of inter-laminar short-circuit faults on the stator cores. Furthermore in order to reduce the risk of creation of fault current loops, the laminations preferably should be isolated from the key-bar of the stator frame.

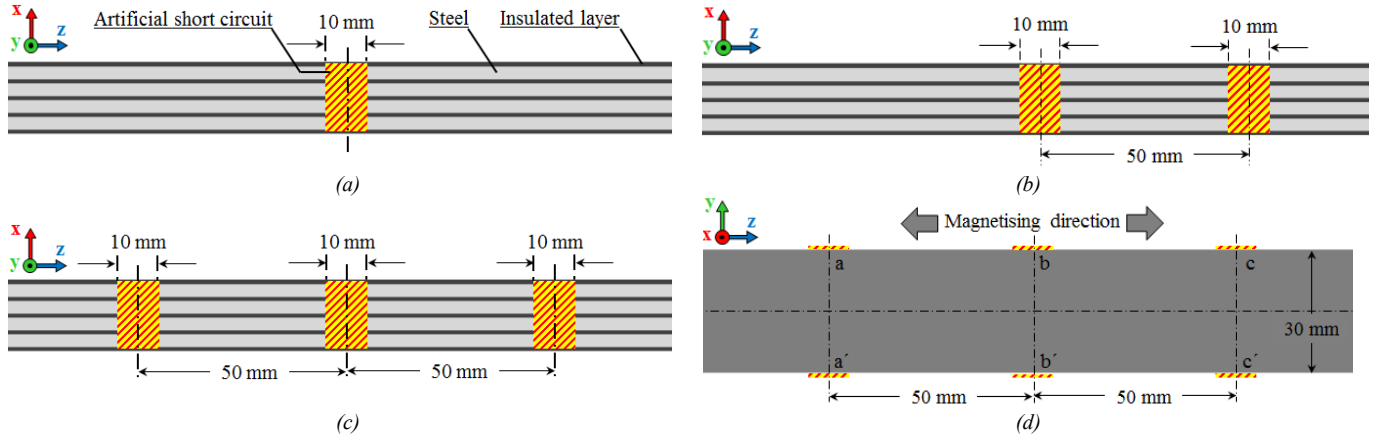
Fig 7 Side view of a stack of four laminations with inter-laminar short circuit applied at (a) one set point (b) two set points and (c) three set points (d) top view of the stack of laminations with inter-laminar short circuit applied at three set points

In the next part of the experiments, effect of inter-laminar short circuits at set positions on total power loss was studied. Specific power loss of the stack without inter-laminar faults was initially measured. Artificial shorts, 10 mm wide, were applied at three positions and the total power loss of the stack was measured in each stage. A schematic side view of the stack with one, two and three shorts are shown in Figs 7-a to 7-c, respectively and a top view of the stack with three shorts is shown in Fig 7-d. In order to obtain the extra power loss caused by the applied short circuits, the power loss in normal operation was subtracted from the total power loss of each stage. The extra losses versus number of the applied short circuits at magnetising frequencies of 50 Hz, 500 Hz and 1000 Hz are shown in Fig 8-a to 8-c, respectively.

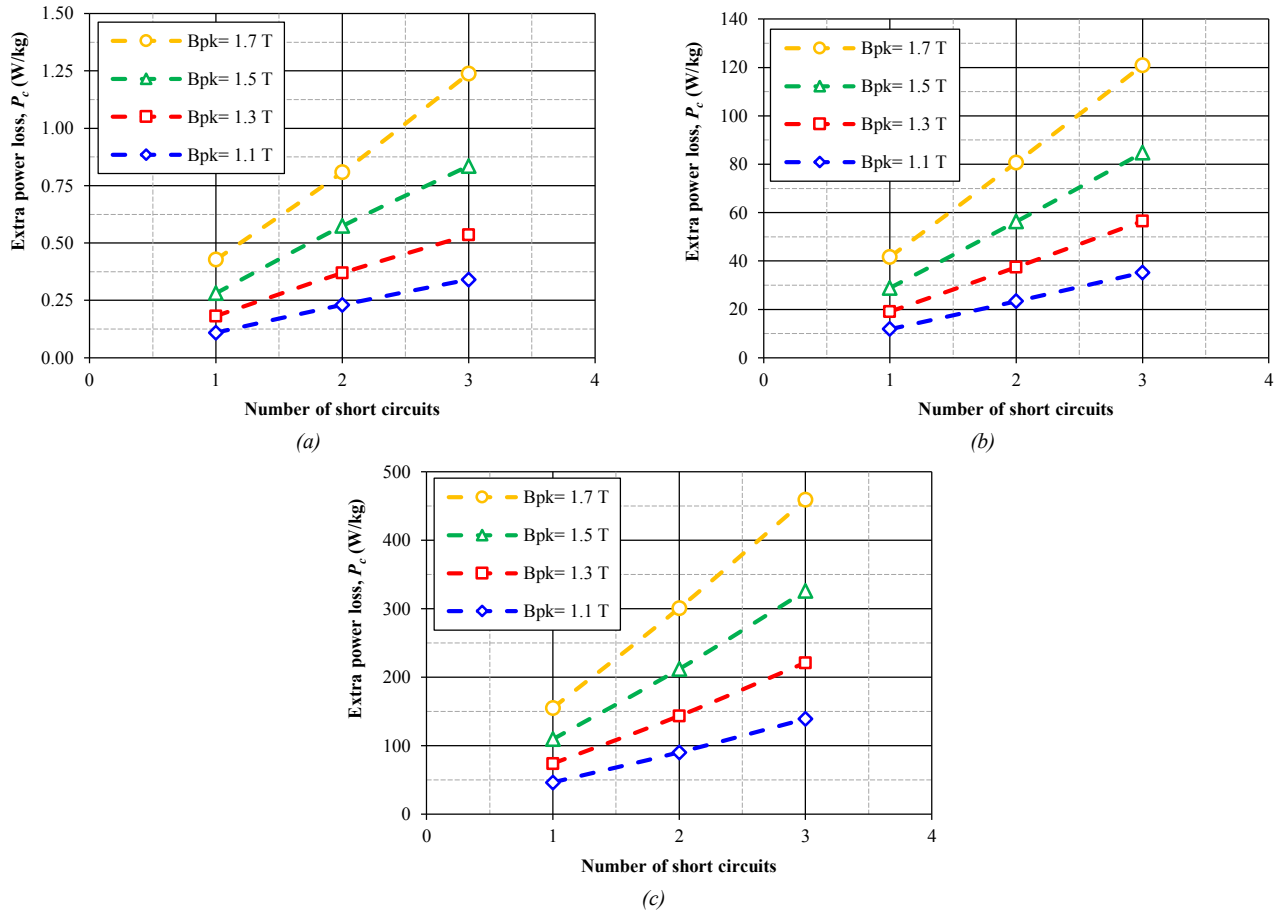
Fig 8 Extra power loss caused by the artificial faults of Fig 7 at frequency of (a) 50 Hz (b) 500 Hz and (c) 1000 Hz

The experimental results of Fig 8 show a linear relation between the extra power loss caused by the applied short circuits and number of the shorts at all flux densities and frequencies. The reason is related to the tendency of the electric currents to flow through the path of least resistance, i.e. in Fig 7-d electric resistance between points $a-a'$ is less than that of points $a-b'$ or $a-c'$. Therefore it can be concluded that the artificial shorts applied to the stack create three independent fault current loops in the stack and hence there is no current flow between the shorted volumes.

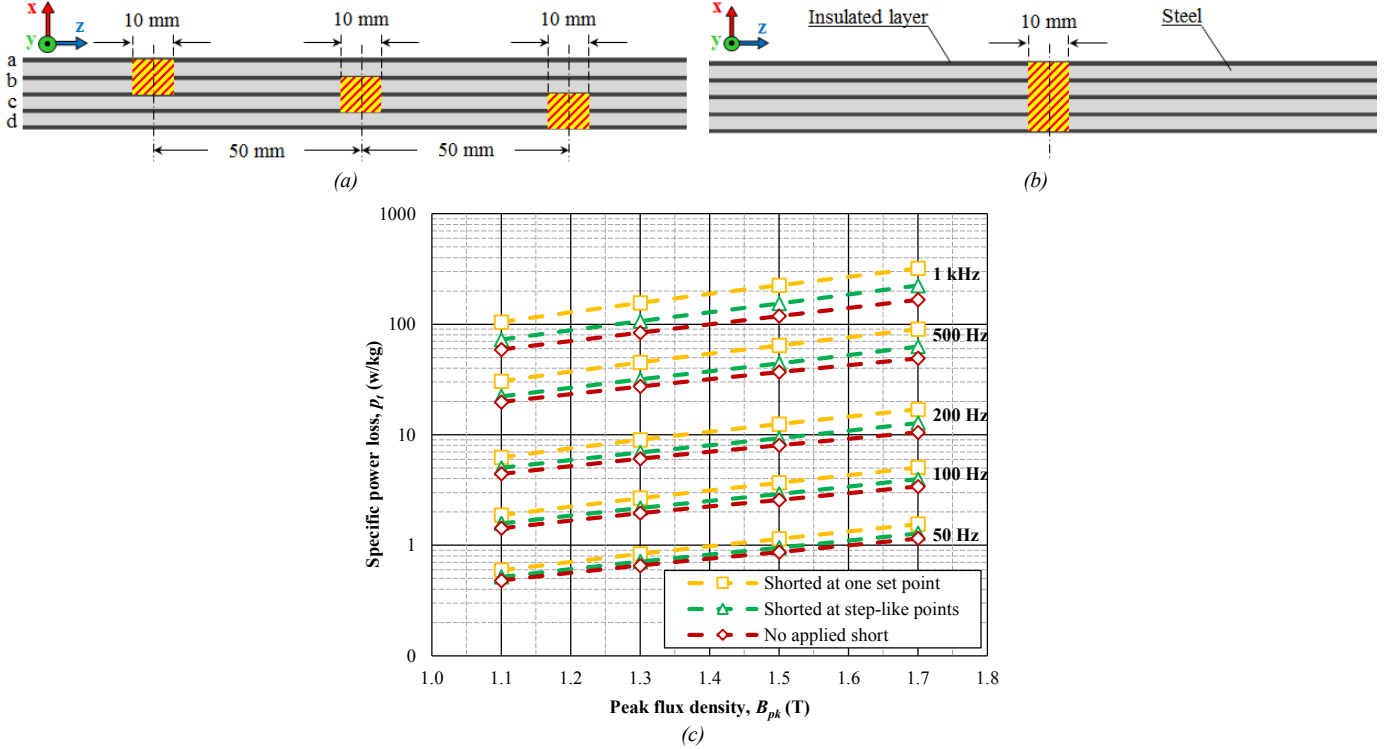
Fig 9 Side view of a stack of four laminations with inter-laminar short circuit at (a) three step-like points (b) one set point (c) total power loss caused by the artificial faults versus peak flux density at magnetising frequencies of 50 Hz to 1000 Hz

As outlined in the introduction, in practice, inter-laminar faults occur at random positions. In order to model this kind of defect, a pack of four laminations were shorted in a step-like configuration with inter-laminar fault between two laminations in each step, Fig 9-a. To qualify the results, another stack of four laminations with a concentrated fault at the centre of the pack was prepared, Fig 9-b. The power loss accompanied by the nominal loss of the material versus peak flux density at different frequencies are shown in Fig 9-c.

Although in both configurations of Figs 9-a and 9-b all of the laminations are shorted, total power loss of the stack with inter-laminar fault at three step-like positions, is less than that with inter-laminar fault at a concentrated point. The reason is related to the nature of the fault current loops created by the artificial shorts. In order to make this issue clear, 2-D FEM modelling was performed at frequencies of 50 Hz and 1000 Hz. The results are shown in Figs 10-a and 10-b, respectively.

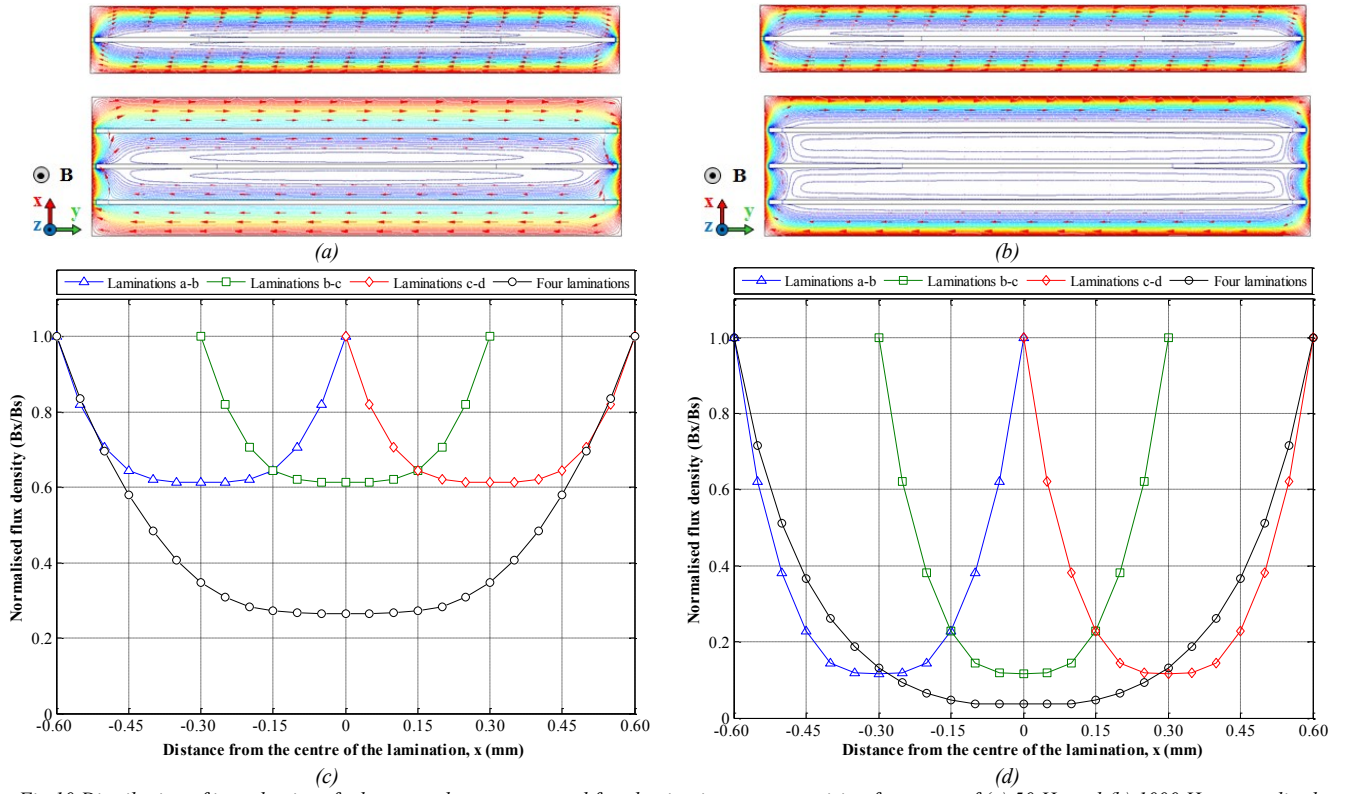
Fig 10 Distribution of inter-laminar fault current between two and four laminations at magnetising frequency of (a) 50 Hz and (b) 1000 Hz; normalized flux density penetration into the stacks of shorted laminations shown in Fig 9 at peak flux density of $B_{pk}=1.3$ T and frequencies (c) 50 Hz and (d) 1000 Hz

An analytical model was already developed by the authors [3] to investigate the distribution of flux density along the thickness of single strip lamination. The model was then extended for packs of shorted laminations. Using the developed model it was proved that a pack of n shorted laminations can be modelled by a single strip with equivalent thickness of $2na$, which $2a$ is thickness of one lamination. It was also shown that an inter-laminar fault causes skin effect to become more significant, which affects the distribution of inter-laminar fault current and hence extra power loss caused by the fault, even at low frequencies. Based on the developed model, distribution of normalised magnetic flux density along the thickness of the shorted packs of Figs 9-a and 9-b at magnetising frequencies of 50 Hz and 1000 Hz and a typical flux density of 1.3 T were calculated; the results are shown in Figs 10-c and 10-d, respectively.

Fig 10 shows that distribution of the inter-laminar fault current and flux density in the shorted stack strongly depend on size of the fault current loop; which in turn depends on the number of the shorted laminations. In Fig 9-a, although there are three fault current loops, the total power loss is less than that of Fig 9-b with only one fault current loop. The reason is related to the size of the fault current loop which is larger in Fig 9-b.

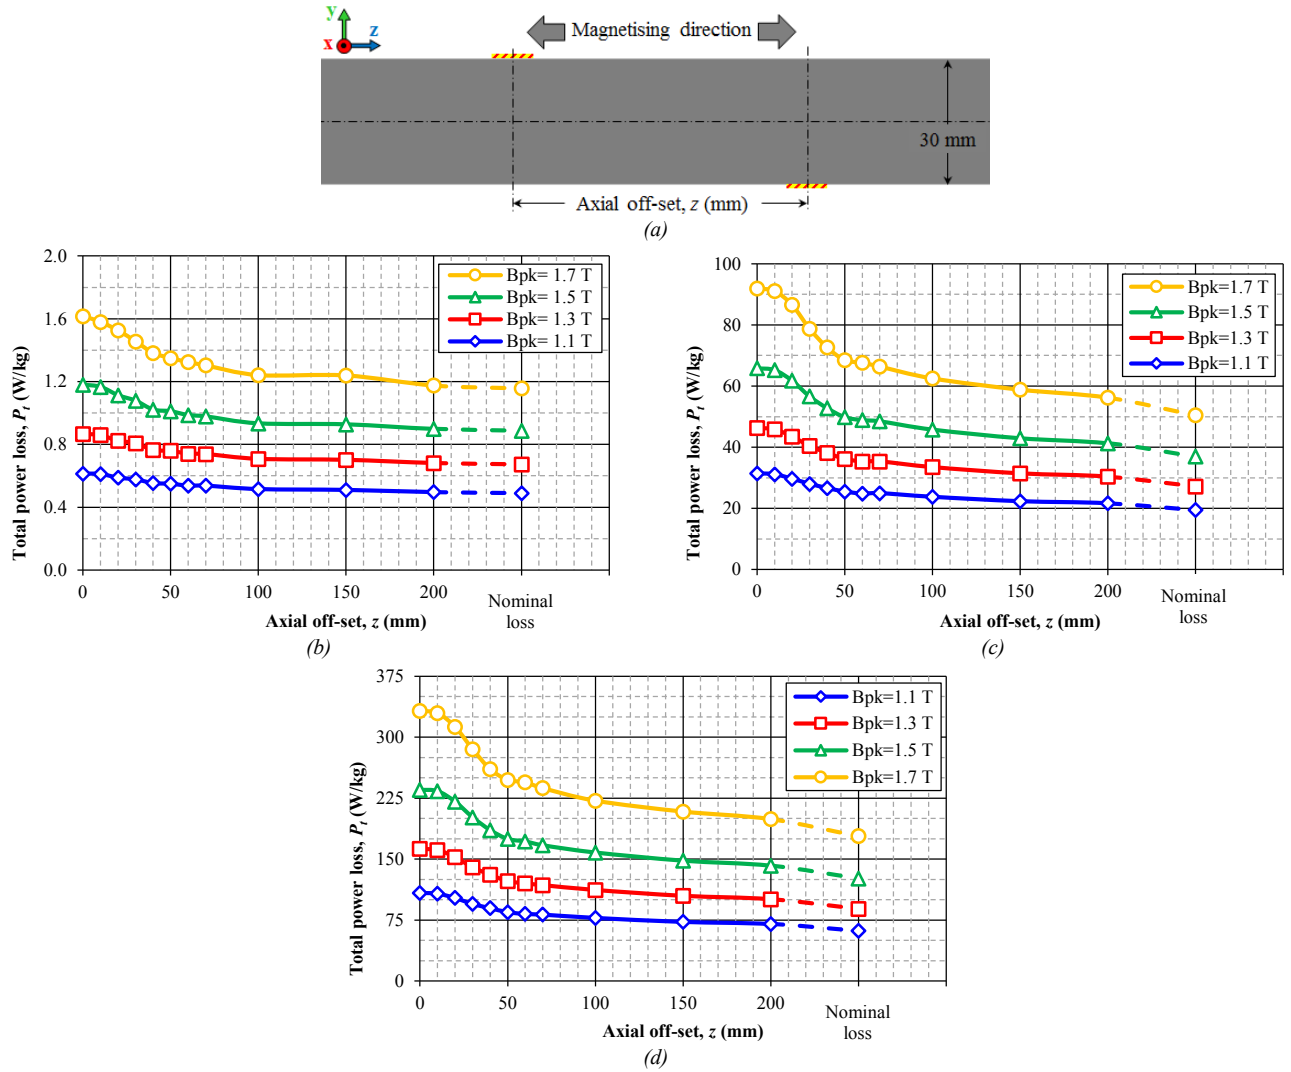
Fig 11 (a) Top view of a stack of four laminations with inter-laminar short circuit with axial off-set position; specific power loss of the stack at magnetising frequencies of (a) 50 Hz (b) 500 Hz and (c) 1000 Hz

When laminations are shorted together at random points by burr at the cut edges, it is also highly likely that there will be a displacement or off-set between the axes of the shorted points of the fault current loops. An off-set between the shorted points in top view of a stack of four laminations is shown schematically in Figs 11-a. In order to simulate these kinds of defect, inter-laminar faults with axial off-sets from 10 mm up to 200 mm were applied separately on opposite sides of packs of four laminations, according to the schematic of Fig 11-a. Each pack was then magnetised and the total magnetic power loss of each stack was measured and recorded separately. The measured power loss versus axial off-set at different flux densities and magnetizing frequencies of 50 Hz, 500 Hz and 1000 Hz are shown in Figs 11-b to 11-d, respectively. Similar to previous sections, nominal power losses of the stacks, with no inter-laminar fault, were measured initially; the results are shown in Fig 11.

Four important notes could be concluded from the experimental results of Fig 11 at all flux densities and frequencies as follow:

1. When the fault points are applied at set points on the same axes, resistance of the fault current loop is at a minimum which leads to a maximum inter-laminar fault current, and hence maximum power loss in the stack.
2. By increasing the axial off-set between the fault points, resistance of the fault current loop is increased, which results in a reduction of the inter-laminar fault current and total power loss of the stack.
3. Significant reduction in power loss was observed up to about 70 mm off-set between the axes of the fault points.
4. Power loss is approaching to the nominal loss of the material when the off-set is above 100 mm. Therefore inter-laminar shorts with high off-set between the shorted points can, in many circumstances, be ignored.

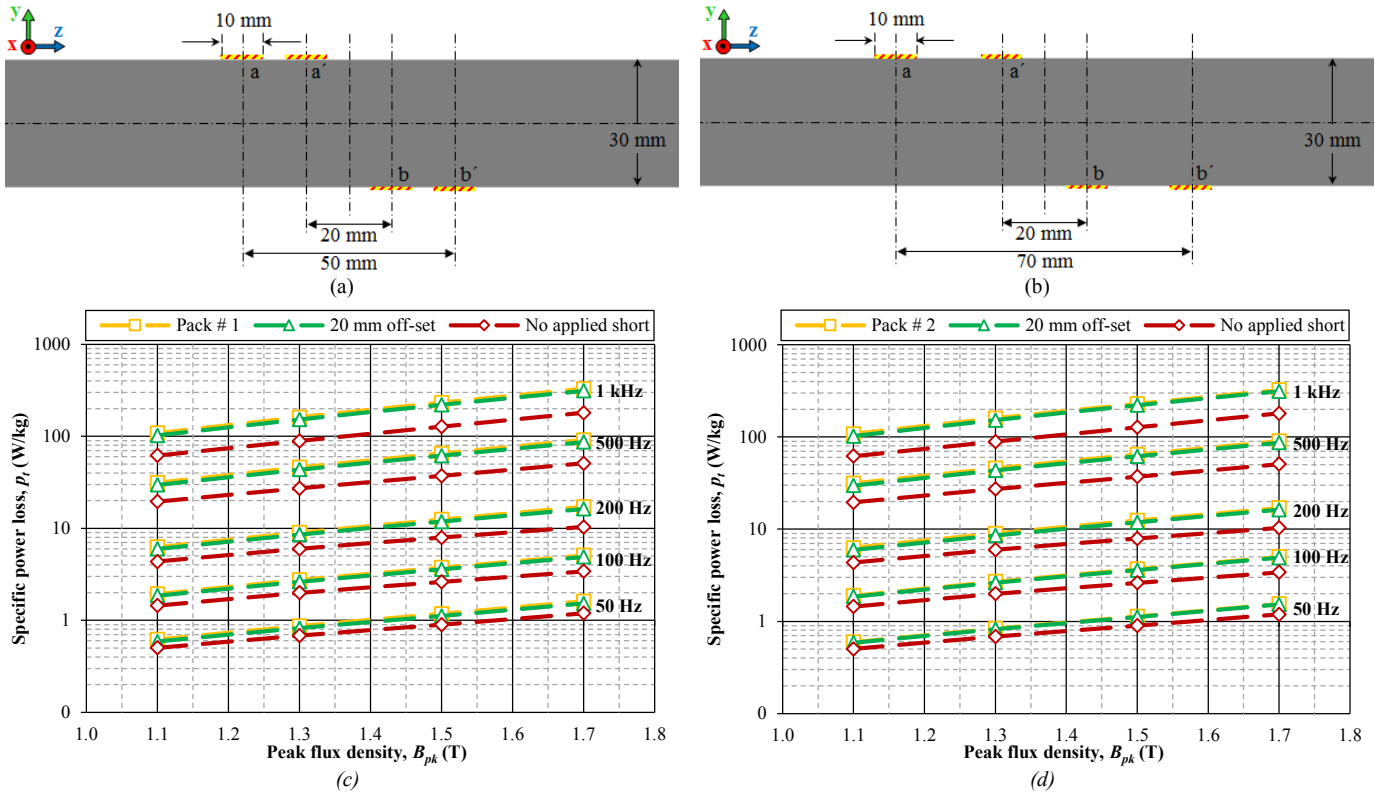
Fig 12 Top view of a stack of four laminations with inter-laminar short circuit at multi off-set positions (a) pack # 1 (b) pack # 2; comparison of total power loss of the packs # 1 and # 2 with the normal loss of the material vs. peak flux density at different frequencies

In the last part of this study the effect of inter-laminar faults at multiple off-set points was investigated. In this work two packs of four laminations were stacked and each pack was shorted at four points with different displacements in the axial axes between the shorted points to make multi off-set faults. Top views of both packs are shown in Fig 12-a and 12-b, respectively. Similar to the other parts of the paper, total power loss of each pack was measured separately. The results obtained from both packs were very close to that of the pack with one short with 20 mm off-set between the shorted points. A comparison between the total power loss of each stack and power loss of the stack with 20 mm off-set and nominal loss of the material are shown in Figs 12-c and 12-d, respectively. Therefore it could be concluded that, the fault current loop in each pack is closed through short circuit points a' and b , and short circuit points a and b' do not make a significant impact on the formation of the fault current loop, inter-laminar fault current and hence extra power loss. The reason is related to the tendency of electric current to pass through low resistance path which, is created between the shorted points a' and b .
